AIRCRAFT ACCIDENT REPORT

**UNCONTAINED ENGINE FAILURE/FIRE
VALUJET AIRLINES FLIGHT 597
DOUGLAS DC-9-32, N908VJ
ATLANTA, GEORGIA
JUNE 8, 1995**

Abstract: This report explains the uncontained engine failure/fire on ValuJet Airlines flight 597, a Douglas DC-9-32, N908VJ, at Atlanta, Georgia, on June 8, 1995. The safety issues discussed in the report include the clarity of operations specifications for repair stations, recordkeeping requirements for foreign repair stations, regulatory guidance concerning maintenance documentation, intent of "serviceable tags," independently powered public address systems on all transport-category airplanes, flight attendant training programs and manuals, enforcement of occupant restraint requirements, notification of flightcrew of cabin fire, cabin material/fire safety standards, flight attendant attire, and quality of cockpit voice recordings. Safety recommendations concerning these issues were made to the Federal Aviation Administration (FAA).

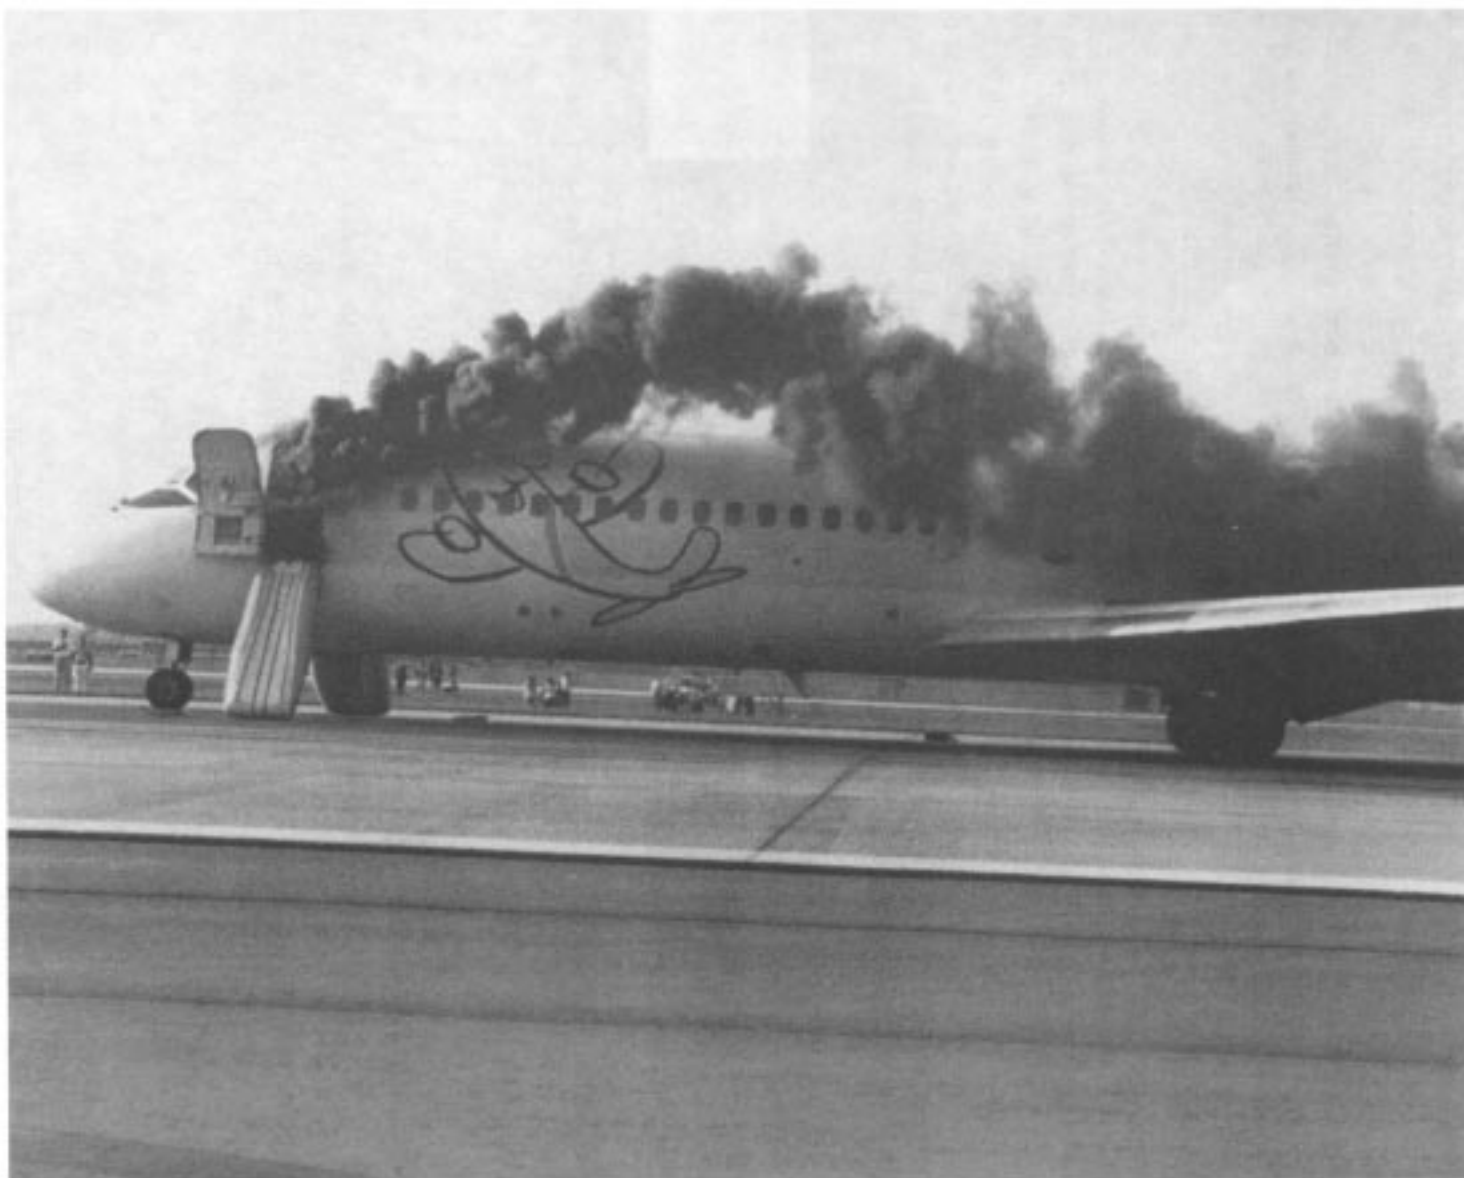
Figure 3—Photograph of flight 597 after uncontained engine failure

The fuselage was destroyed by fire, which gutted the interior, burned through the roof of the forward cabin area of the airplane, and consumed most of the cabin overhead. There was substantial exterior damage with circumferential outward tearing of the right engine cowl and engine case in the plane of rotation of the right engine 7th stage high pressure compressor (HPC) disk. There was also shrapnel damage to the fuselage and left engine cowl.

were ragged and curled outboard, away from the center of the engine. The forward edges of the hole were burned, with the paint blistered and charred. The nacelle was heat damaged from about the 1 to 6 o'clock position, to about 15 inches forward of the circumferential opening. The nacelle lower half was covered with soot aft of the circumferential opening.
